Effects of via-conductor geometry in the electromigration failure of Al:Cu wires

R. Leon, D. Vu, A.S. Johnson, R. Ruiz, J. Okuno, J. Uribe, and G. Hather
*Jet Propulsion Laboratory, California Institute of Technology, 4800 Oak Grove Drive,
Pasadena, CA 91109*

J. R. Lloyd
*IBM Research Division, Thomas J. Watson Research Center, Yorktown Heights, NY
10598*

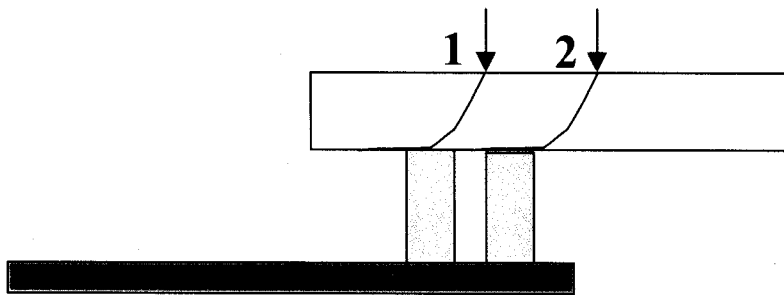
Colinear conductor geometry shows well defined
“steps in the Resistance vs. time curves

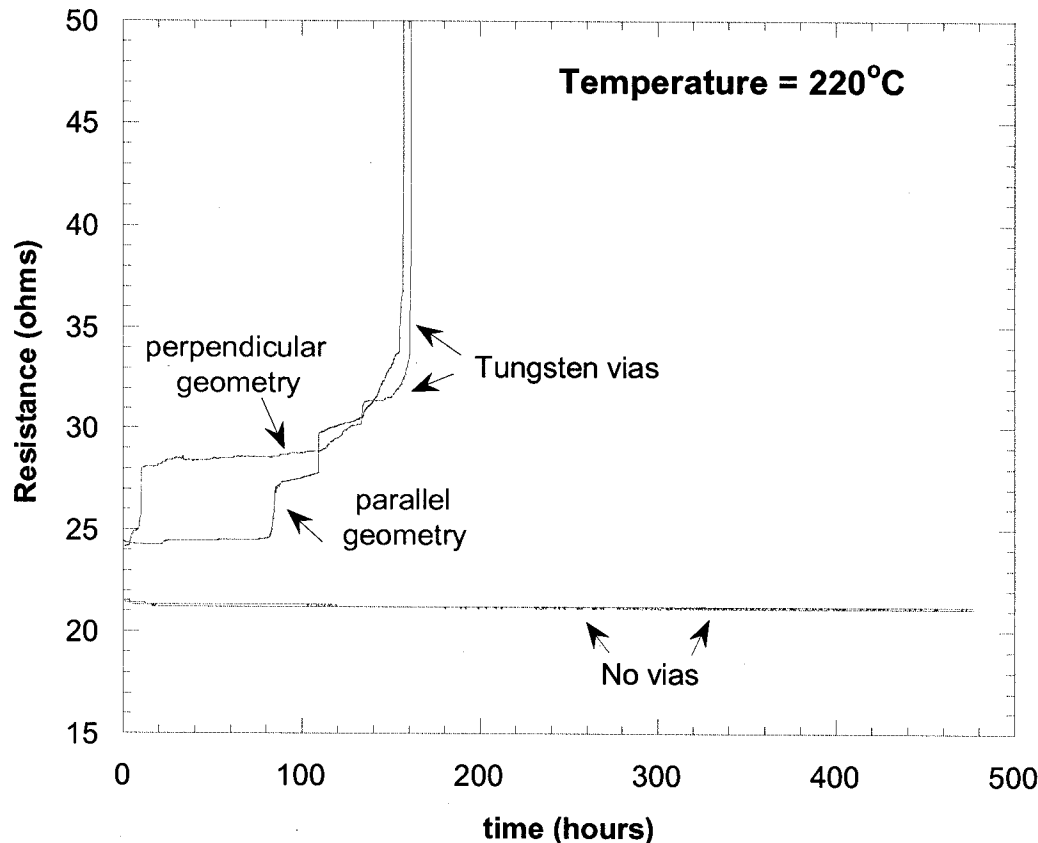
Dramatic differences in degradation seen in tests with and without vias (1 and 2 layer metallization)

This observation can be explained by the absence of flux divergence in the no-via 1 layer structure. Previous studies have shown that the interface between the Al conductor and the refractory metal (W plug) is most vulnerable to voiding. This is due to the discontinuity in the flux of electromigrating Al atoms.

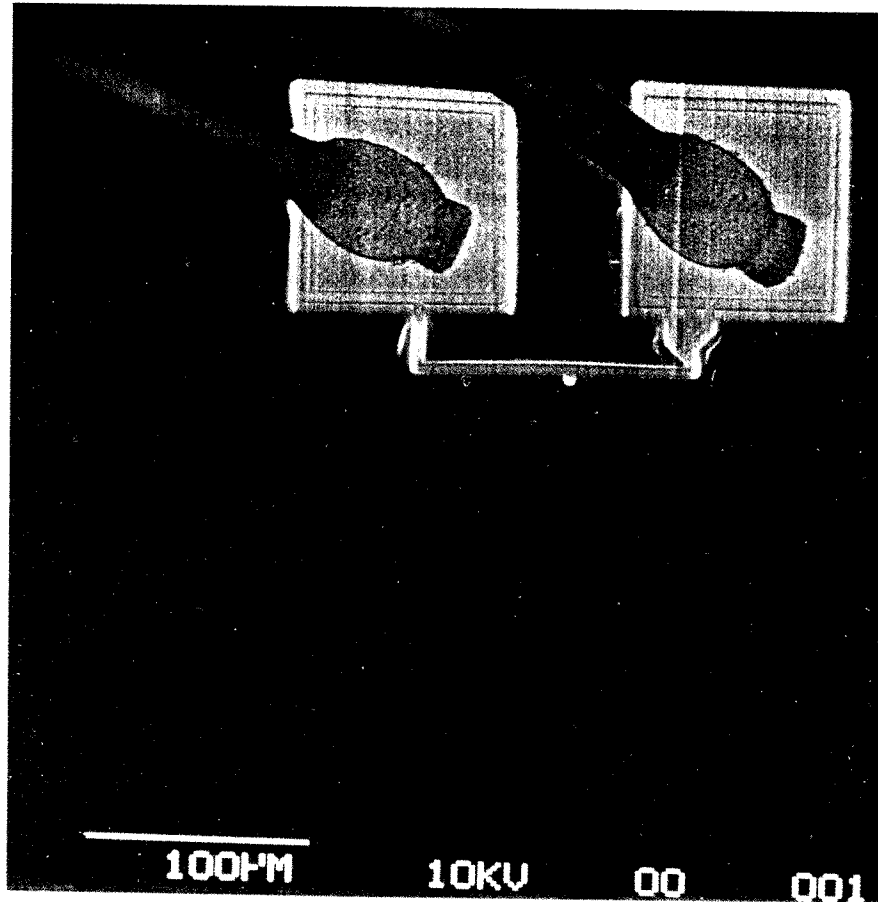
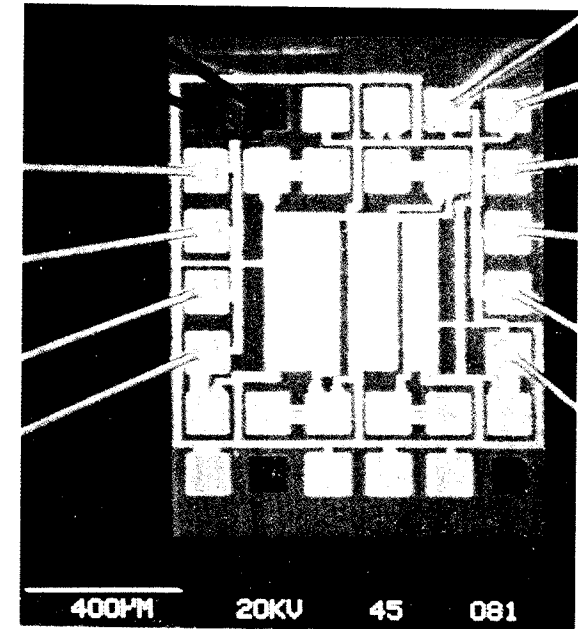
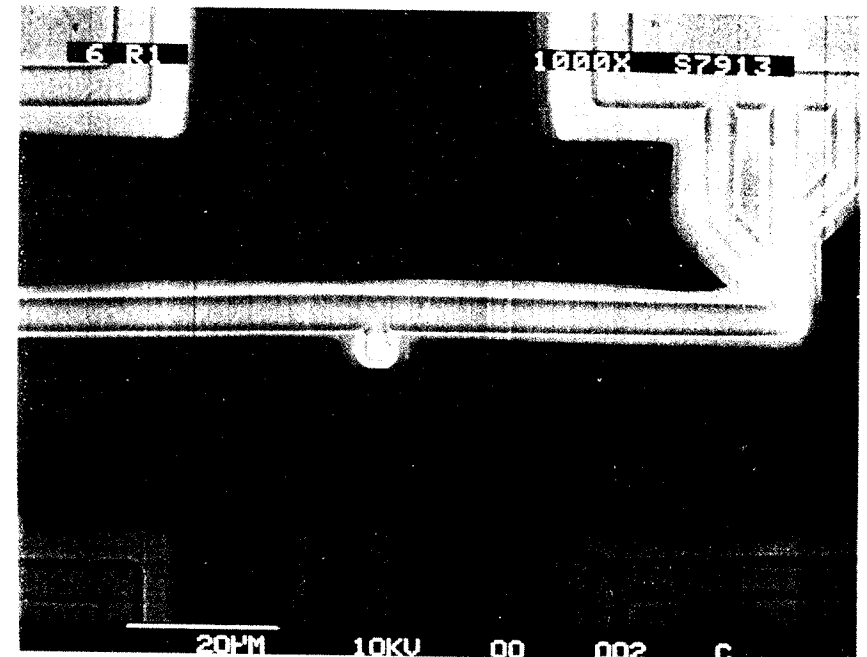
EBIC analysis of open circuit structure after electromigration testing at 220 C

Failure point cannot be seen in plan-view (top) imaging even for an open circuit failure after electromigration testing.

Connections were reversed to ensure that failure is only at one of the two vias

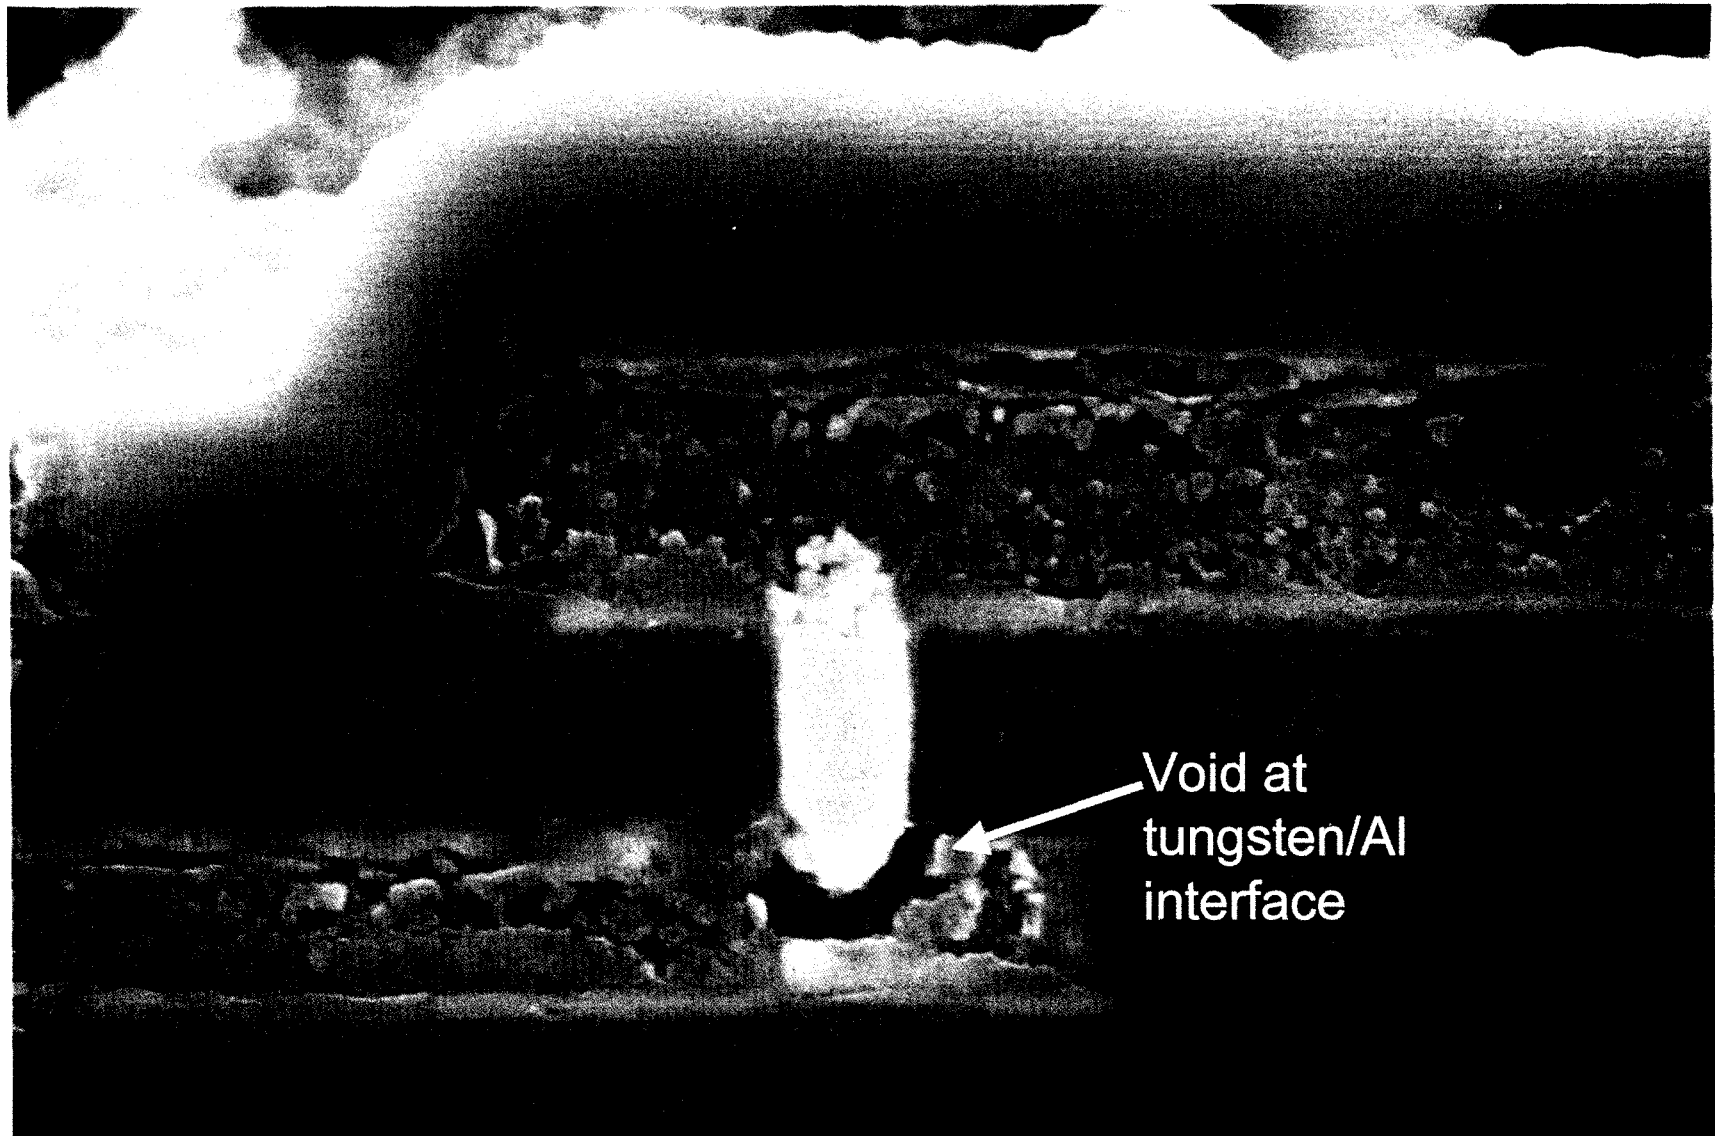
Void at
tungsten/Al
interface

Cross-sectional SEM image of voided area at Tungsten/Al:Cu interface. Void was formed from electromigration testing at 240 C and structure failed catastrophically (open circuit).

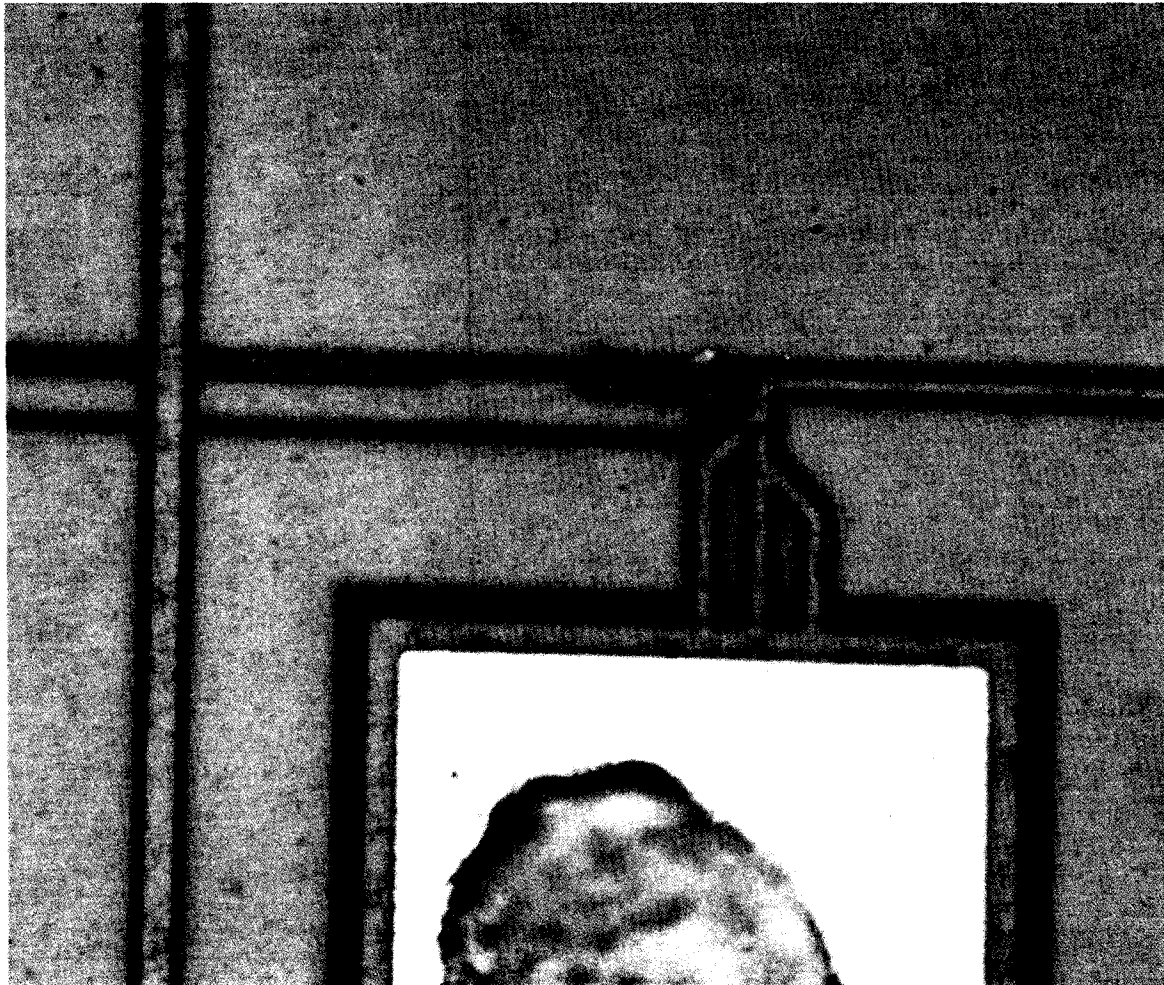
Problems (1): High ESD (electrostatic discharge) sensitivity.
Damage often seen in dry winter days

Solution:

1. Use appropriate ESD precautions during test structure handling (according to the JPL Standard for ESD Control, ~~found in D-1348 Rev. D)~~^e
2. Store structures in ESD bags or boxes in between tests or after testing and prior to cross-sectioning

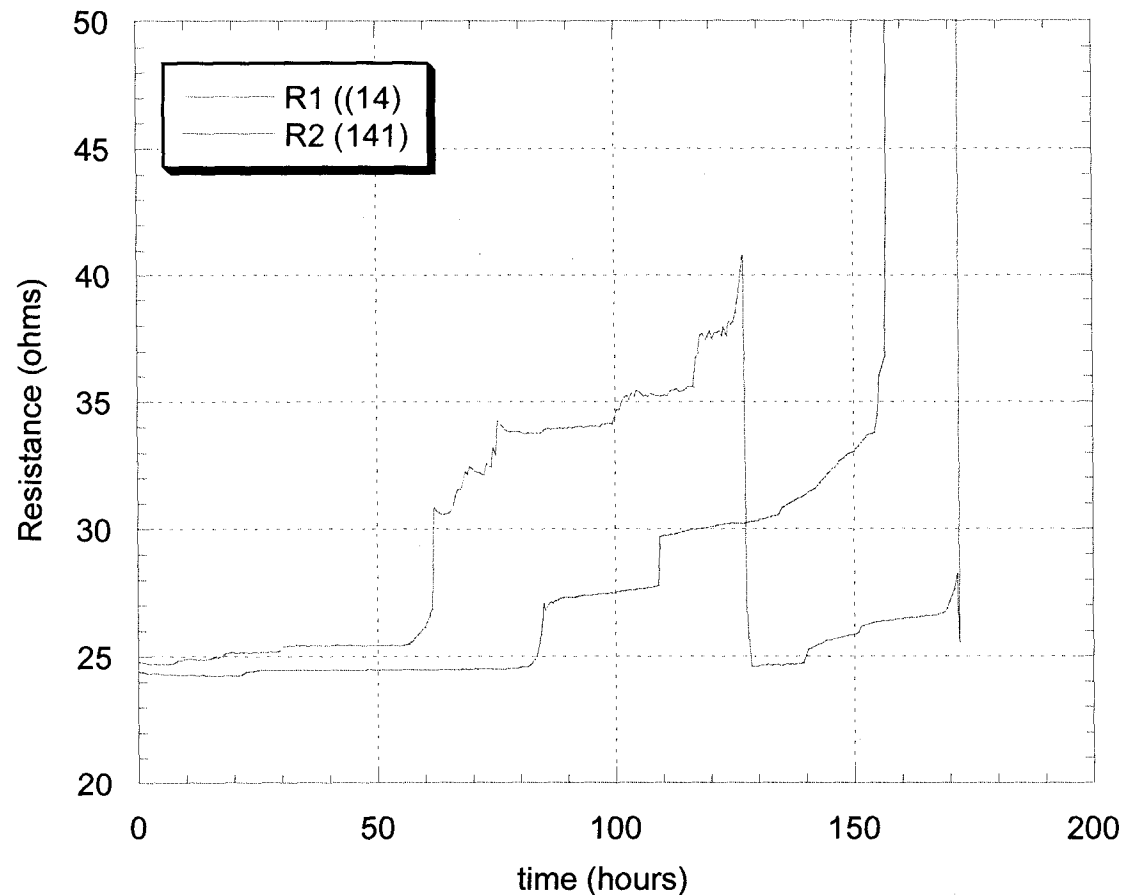
Problem (2): Ultrahigh current densities in thinning areas can cause arching with localized melting of metals and partial structure “repair”. This is undesirable for cross-sectional studies since this process might mask “real” (meaning electromigration induced) degradation mechanism.

Curve for R1 (red) shows a case of localized metallization “repair” due to melting of metals at ultra-high current densities after Al conductor thinning due to electromigration induced voiding.

Test can be stopped earlier, before circuit is completely open.
